# Neutral Corrosion-Significance, Causes & Mitigation

G.J. Bertini  
Novinium, Inc.  
34110 9<sup>th</sup> AVE S, STE B  
Federal Way, WA 98003 USA

**Key Words-** Neutral Corrosion, IEEE 1617™.

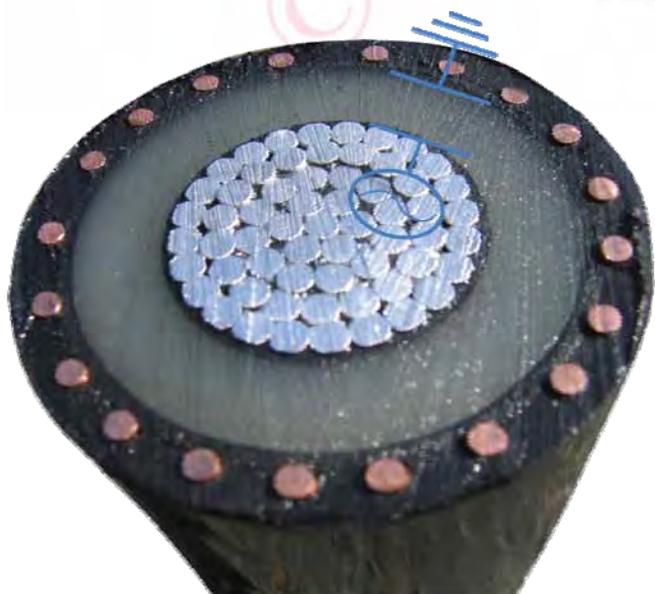
**Figure 1.** The neutral bleeds charging currents induced on the shield.

The neutral has four primary purposes. The first purpose (IEEE 1617 4.1) is to bleed currents induced onto the cable shielding. This concept is illustrated in Figure 1. The cable is not a particularly good capacitor as the distance between the two electrodes is large and the dielectric constant of the insulation is quite low – about 2.3 for PE cables. Very little neutral conductor is required to bleed these small charging currents.

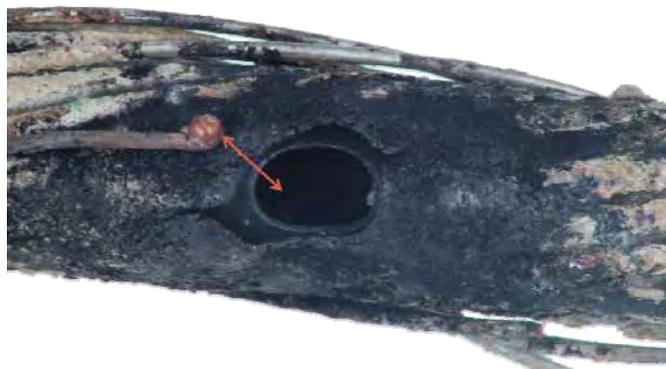
**Figure 2.** Fault currents follow the lowest impedance path to ground. Ideally the neutrals provide that path.

The second purpose (IEEE 1617 4.2) is to provide a low impedance path for fault currents. This fault current path is particularly important for protective devices such as fuses and circuit breakers to operate as quickly as possible. Figure 2 shows a cable fault. The melted copper illustrates the high current that jumped from the conductor to the neutral. If the neutral is corroded, the fault current will find alternate paths including the soil and other nearby utilities. Where the impedance is very high, protection tripping might be delayed.

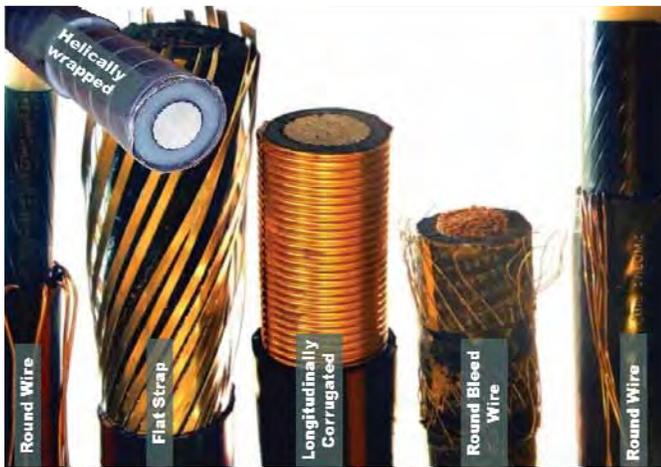
**Figure 3. Neutral shielding have been manufactured with a wide variety of configurations.**

Figure 3 provides a sampling of a variety of neutral configurations that have been employed.

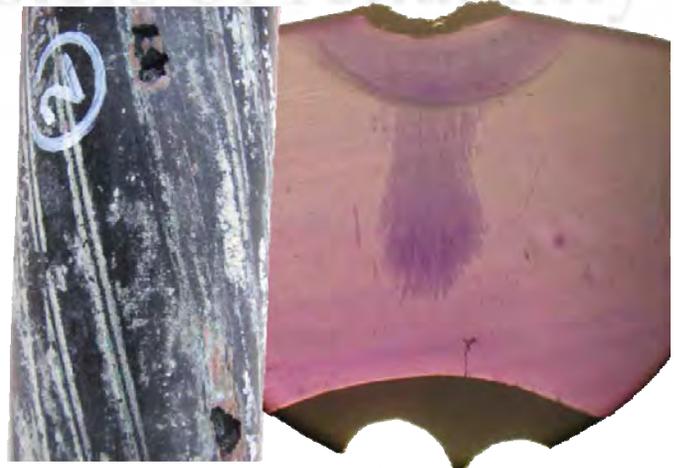
**Figure 5. Holes in the cable insulation shield were created by arcing from compromised neutrals. The erosion reached the insulation; water trees and electrical trees formed.** Images courtesy of Cable Technology Laboratories.

There are 5 potential consequences identified by 1617 for cables that suffer significant neutral corrosion. First, Section 5.1 explains that the loss of the defined, low-impedance path for charging currents may result in currents along "unintended" paths. The surface of the non-metallic shield layer may suffer significant local heating and erosion of the layer by arcing. Such events may ultimately expose the insulation. The result is concentrated electrical stress, localized heating, and potentially cable failure. Figure 5 provides two views of an example of a cable which failed by this mechanism.

Dielectric failures of cables due to neutral corrosion as suggested by IEEE 1617 5.1 and of which Figure 5 is an example are not a common occurrence. In 1994, the ICC task force that was the forerunner of the IEEE 1617 writing effort published a seven-year survey of circuit owners reported neutral problems. There was a 5-year period where that survey overlapped with a similar survey called the “AEIC Cable Report.” Those two reports are summarized in Figure 6 side-by-side. The table compares the reported incidents of cable failure to the reported incidents of neutral problems. The ratio of cable failures to neutral issues varies to between 10 and 25. Neutral corrosion is at least 10X less significant than cable failures. The Figure 6 table was published by Bob Gurniak of Pennsylvania Power & Light in T&D World in 1996 [2].

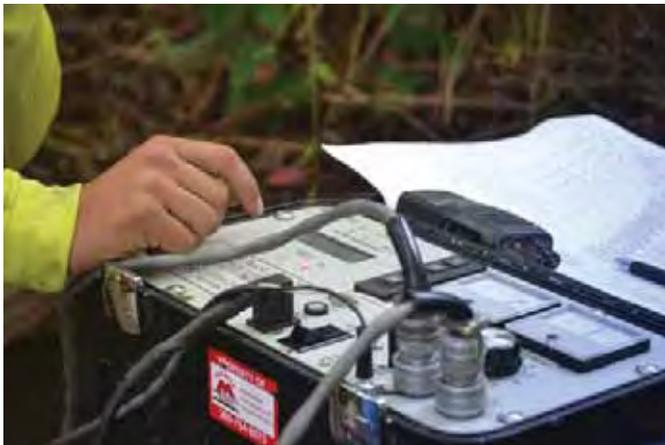
Figure 15. The front-end of an  $\Omega$ -check. This device is no longer being produced or supported. A limited number remain in service.

The resistance measuring technology has a small following and remains in use today, but never enjoyed significant commercial success. A device branded as  $\Omega$ -check (Ohm-check) was the most common instrument and is no longer being manufactured. The device is pictured in Figure 15.

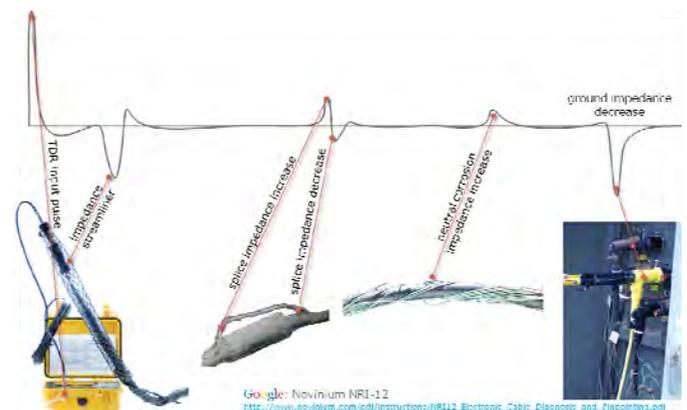
Figure 16. The principals of TDR used to identify and distinguish neutral corrosion impedance reflections from other anomalies such as splices. Virtual representations in the waveform are tied to their physical manifestations.

Figure 16 illustrates the principles of TDR use. Working from left to right in Figure 16, the TDR transmits a narrow low voltage pulse down a coaxial cable. The pulse is less than 20 volts and has a width of between 1 and 50 ns. The pulse travels at about half of the speed of light.

A device called an impedance streamliner facilitates a smooth transition from the impedance of the RG-coaxial cable to various sizes of co-axial power cables. The streamlined transition minimizes the reflection, attenuation, and dispersion of the signal as it enters the subject cable. The use of a streamliner improves the sensitivity and accuracy of the measurement. The default connection provided by TDR manufactures is a pair of alligator clips. While the clips make for simple connections, the loss of resolution is unacceptable for detecting neutral corrosion.

Where splices are present in the cable a characteristic S-wave is observed. Impedance includes resistance, capacitance and inductance. In the case of a splice, the neutrals are trained away from the conductor, which reflects a positive wave because the impedance increases. The subsequent negative wave is a result of the neutrals returning to a position closer to the conductor decreasing the impedance.

Where there is neutral corrosion, the resistance increases and the capacitance decreases, but the former dominates and a positive wave is created. The capacitance effect is generally too small to observe. A glance back at Figure 12 allows the operator to assess the extent of the corrosion anomaly. It is level 2 corrosion; 25% to 50% of the neutrals are severed.
